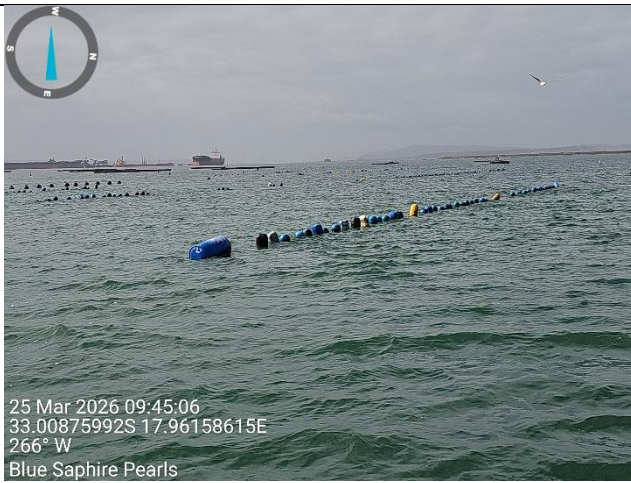
**Photograph 1:** Lines were taut and muted in colour.

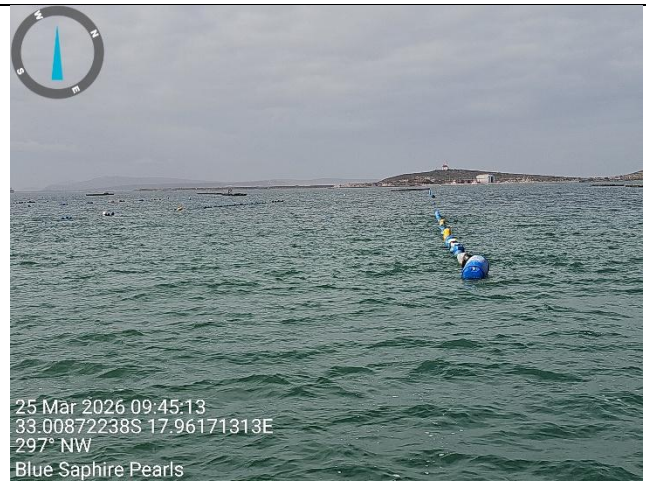
**Photograph 2:** Lines were taut and muted in colour.

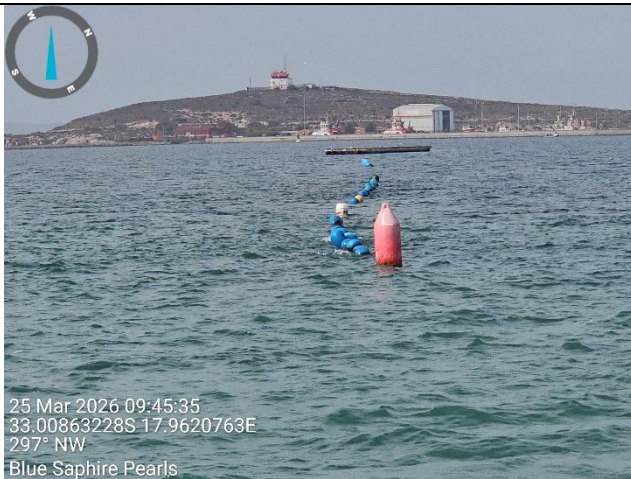
**Photograph 3:** Lines were taut and muted in colour.

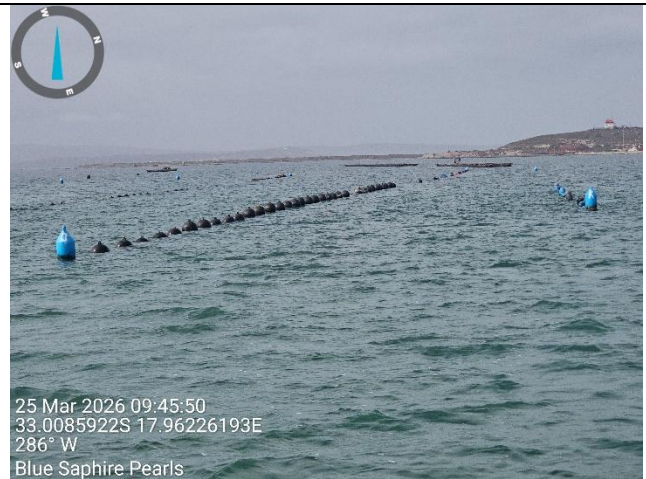
**Photograph 4:** Lines were taut and muted in colour.

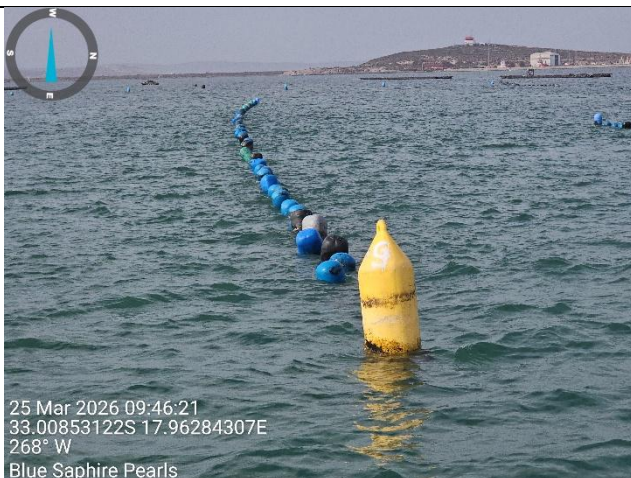
**Photograph 5:** Lines were taut and muted in colour.

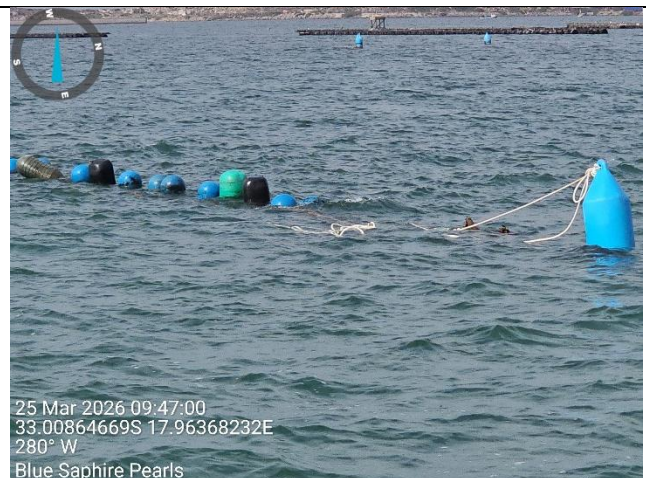
**Photograph 6:** Loose rope was observed at one of the lines.

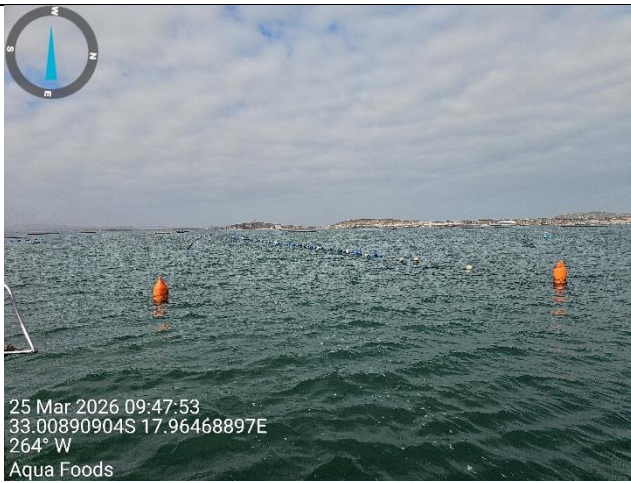
25 Mar 2026 09:47:53  
33.00890904S 17.96468897E  
264° W  
Aqua Foods

**Photograph 7:** Lines were taut and muted in colour.

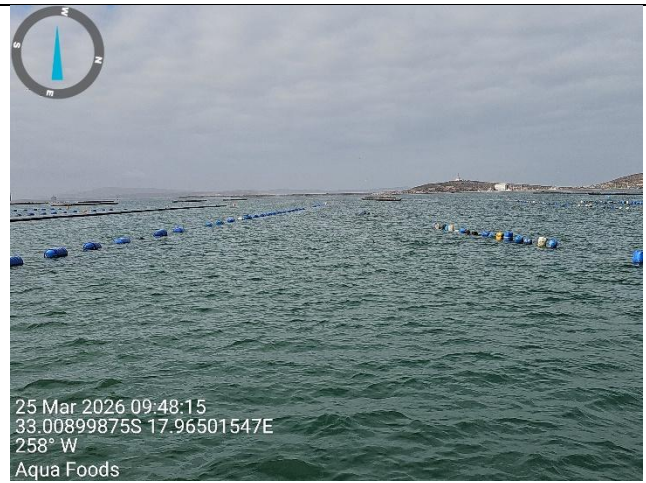
25 Mar 2026 09:48:15  
33.00899875S 17.96501547E  
258° W  
Aqua Foods

**Photograph 8:** Lines were taut and muted in colour.

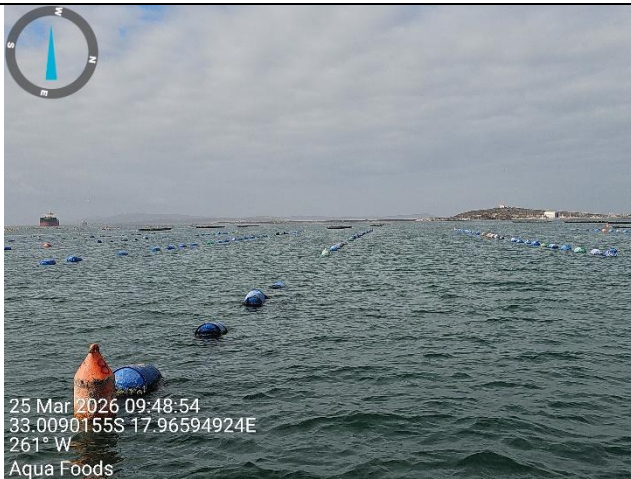
25 Mar 2026 09:48:54  
33.0090155S 17.96594924E  
261° W  
Aqua Foods

**Photograph 9:** Lines were taut and muted in colour.

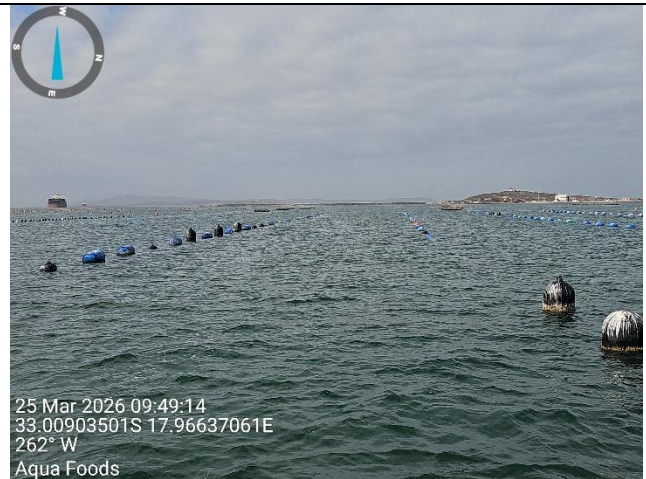
25 Mar 2026 09:49:14  
33.00903501S 17.96637061E  
262° W  
Aqua Foods

**Photograph 10:** Lines were taut and muted in colour.

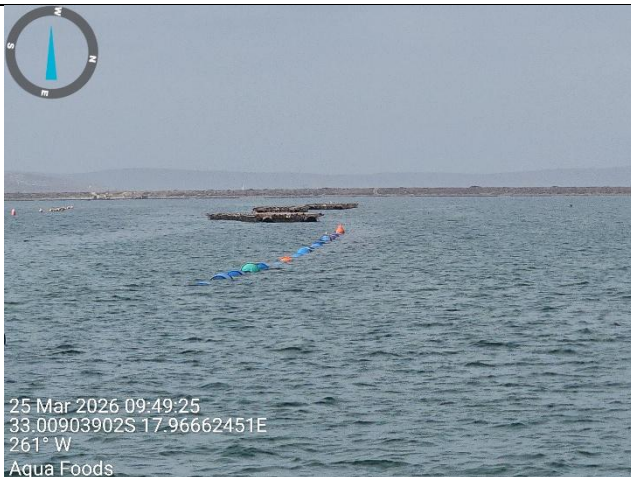
25 Mar 2026 09:49:25  
33.00903902S 17.96662451E  
261° W  
Aqua Foods

**Photograph 11:** Lines were taut and muted in colour.

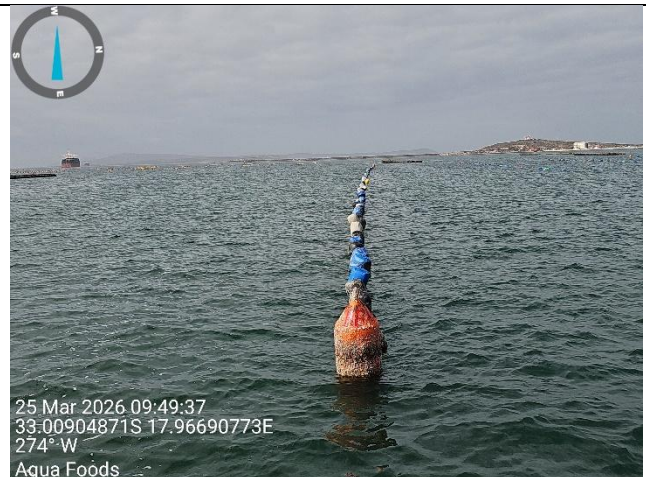
25 Mar 2026 09:49:37  
33.00904871S 17.96690773E  
274° W  
Aqua Foods

**Photograph 12:** Lines were taut and muted in colour.

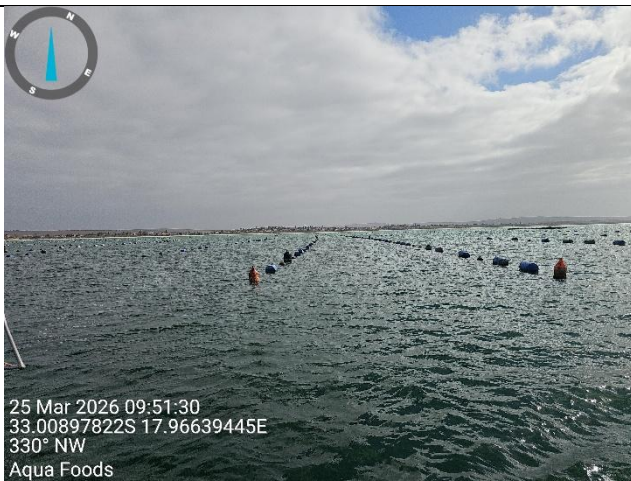
**Photograph 15:** Lines were taut and muted in colour. Identifying markers were hard to observe.

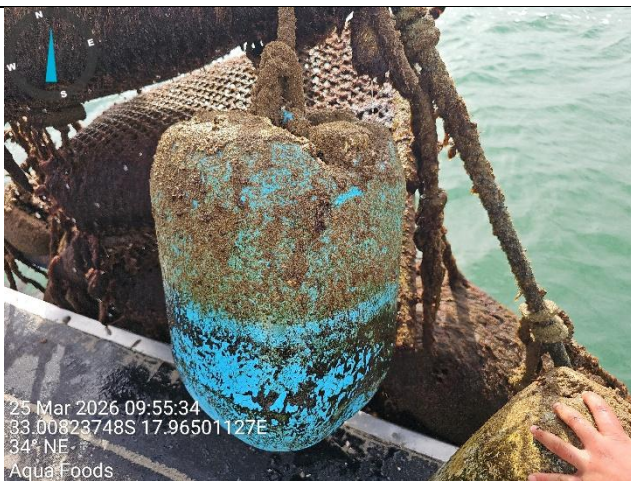
**Photograph 17:** No identifying markers was observed on the cages.

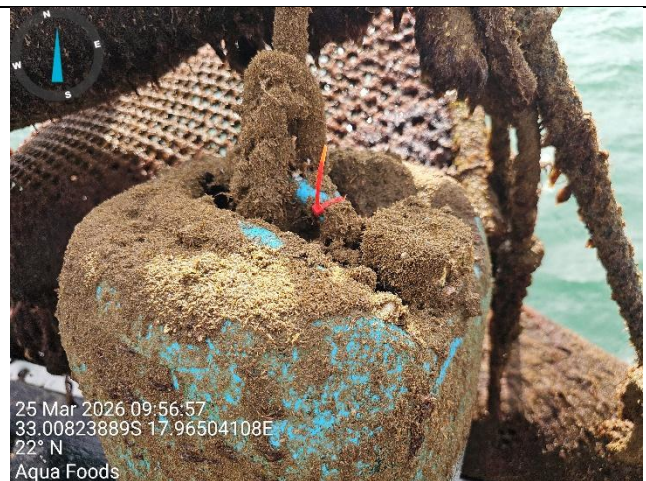
**Photograph 18:** A red cable tie was added to the buoy by the captain of the vessel.

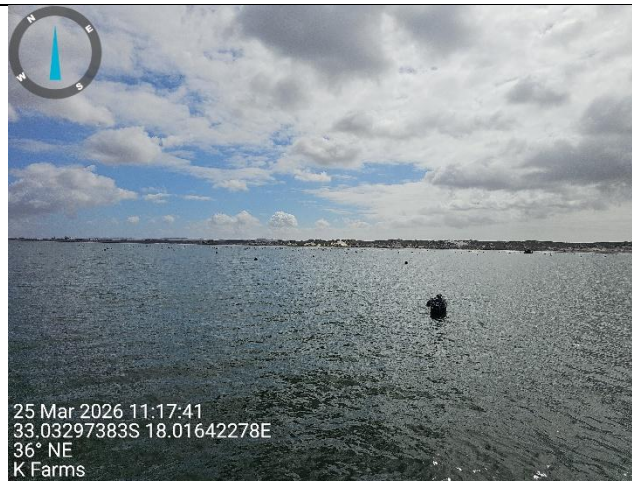
**Photograph 32:** No lines were observed in the water for K Farms. Dormant aquaculture farm.

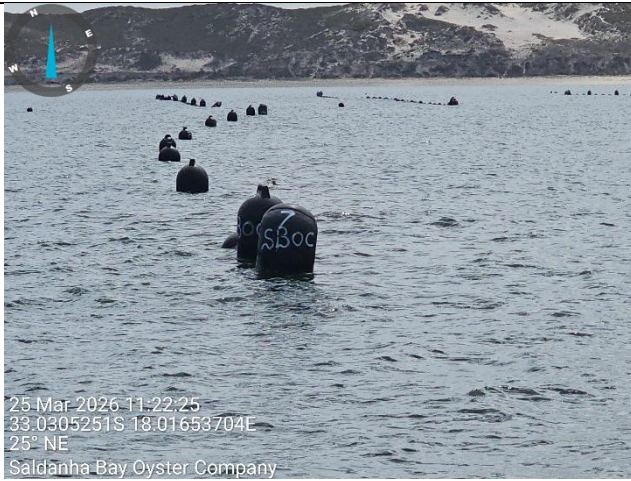
**Photograph 37:** Lines were taut and muted in colour. Spray paint and reflectors was used to identify the lines of Saldanha Bay Oyster Company (SBOC).

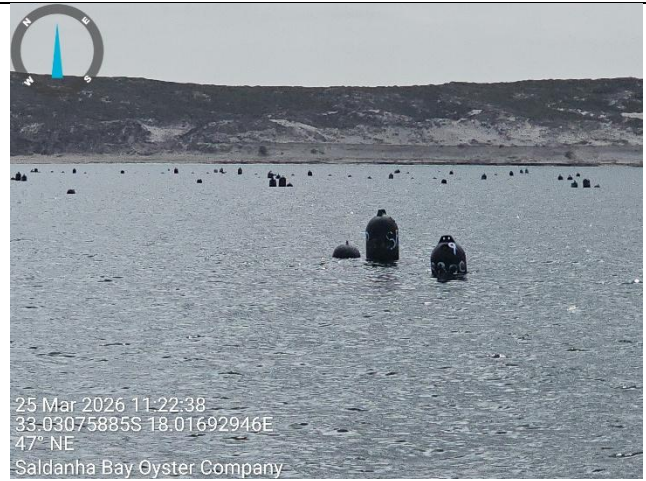
**Photograph 38:** Dormant lines were observed at SBOC.

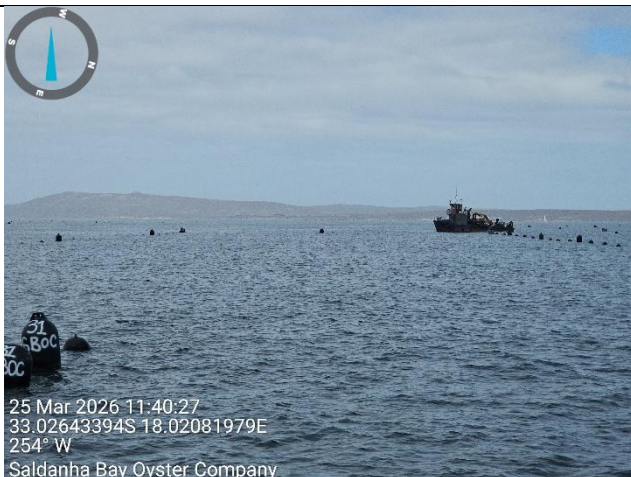
**Photograph 53:** Vessel observed harvesting during on water inspection. No oil slicks were observed.

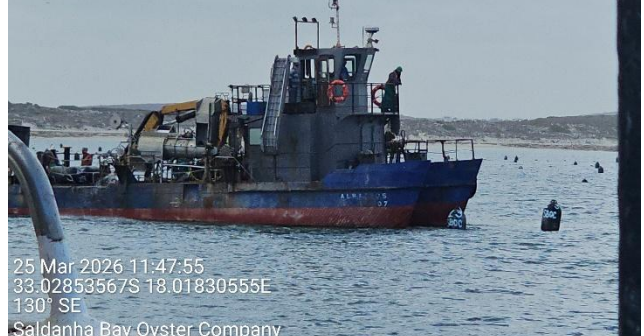
25 Mar 2026 11:47:55  
33.02853567S 18.01830555E  
130° SE  
Saldanha Bay Oyster Company

**Photograph 60:** Vessel observed harvesting during on water inspection. No oil slicks were observed.

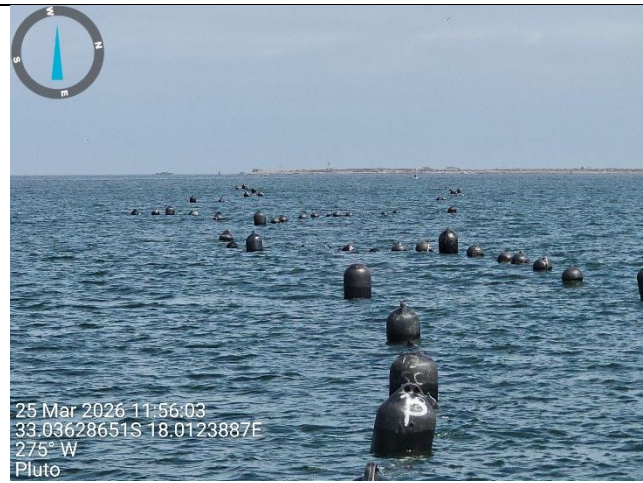
**Photograph 62:** Some of the Pluto lines seemed to be tangled.

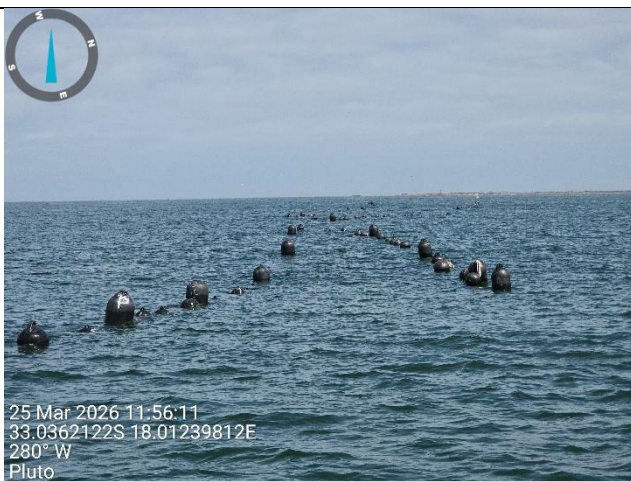
**Photograph 63:** Some of the Pluto lines seemed to be tangled.

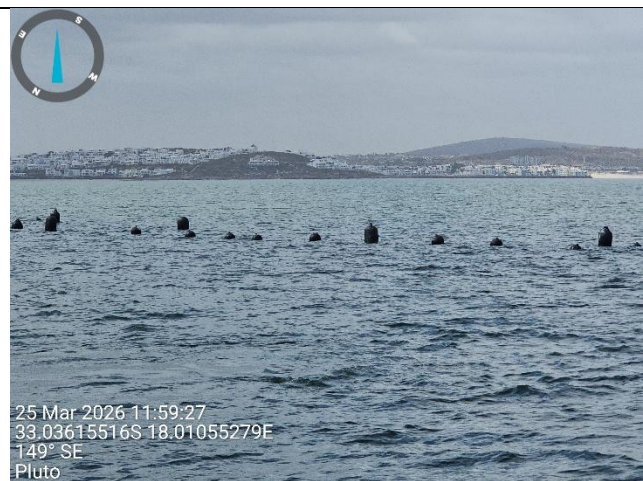
**Photograph 64:** Some of the Pluto lines seemed to be tangled.

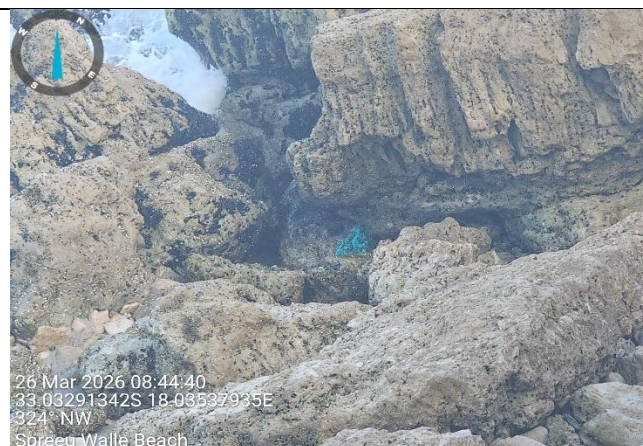
**Photograph 66:** Piece of rope observed at Spreu Walle Beach during the beach inspection. Refer to co-ordinates on photo for location.

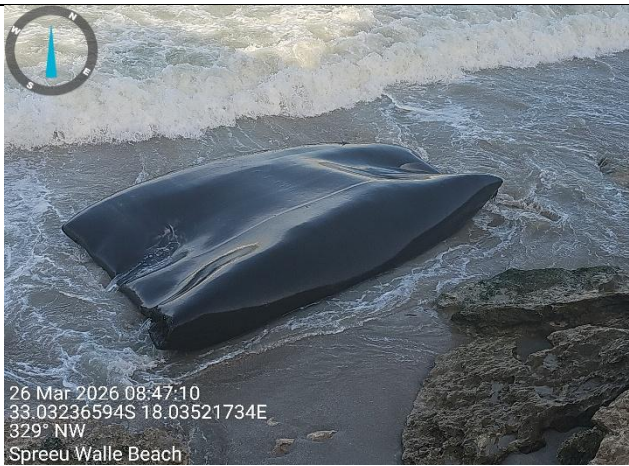
**Photograph 67:** Floating debris observed at Spreeu Walle Beach during the beach inspection. Refer to co-ordinates on photo for location.

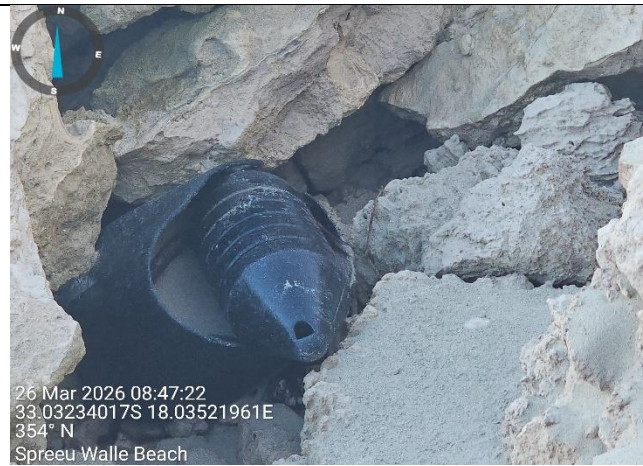
**Photograph 68:** Buoy observed at Spreeu Walle Beach during the beach inspection. Refer to co-ordinates on photo for location.

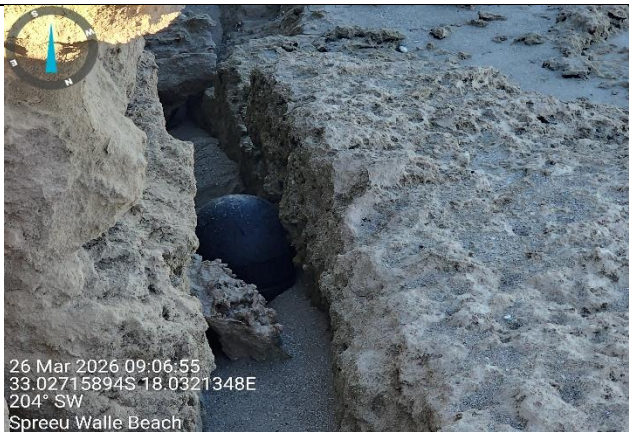
**Photograph 69:** Buoy observed at Spreeu Walle Beach during the beach inspection. Refer to co-ordinates on photo for location.

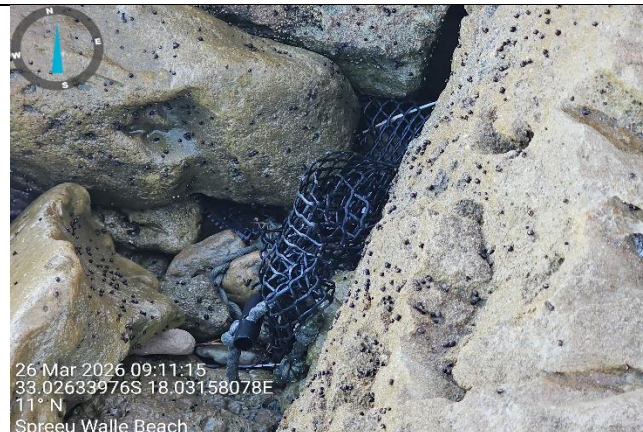
**Photograph 70:** Piece of cage observed at Spreeu Walle Beach during the beach inspection. Refer to co-ordinates on photo for location.

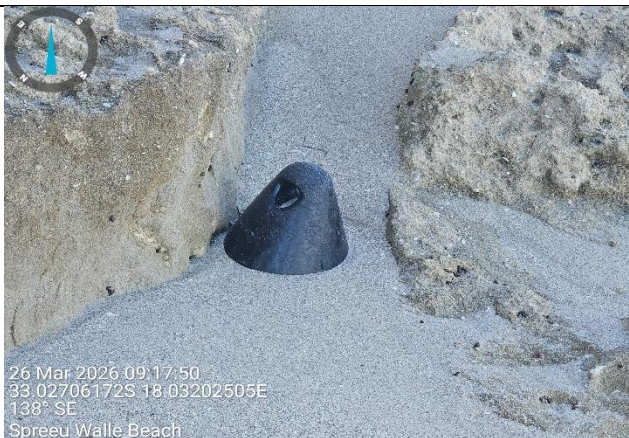
**Photograph 71:** Buried buoy observed at Spreeu Walle Beach during the beach inspection. Refer to co-ordinates on photo for location.

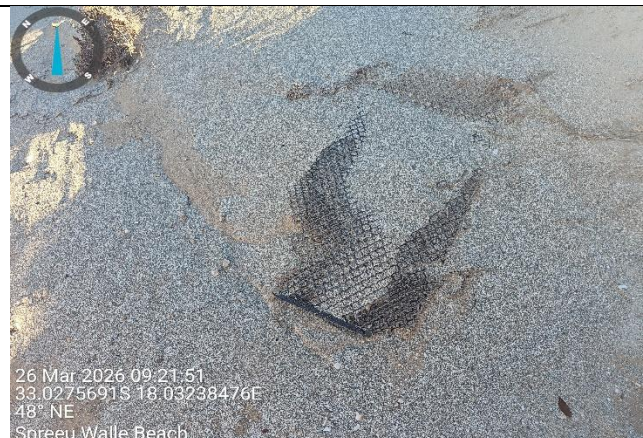
**Photograph 72:** Piece of cage observed at Spreeu Walle Beach during the beach inspection. Refer to co-ordinates on photo for location.

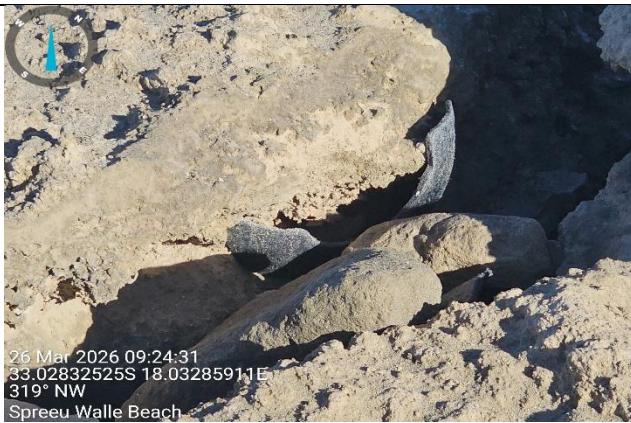
**Photograph 73:** Piece of buoy observed at Spreeu Walle Beach during the beach inspection. Refer to co-ordinates on photo for location.

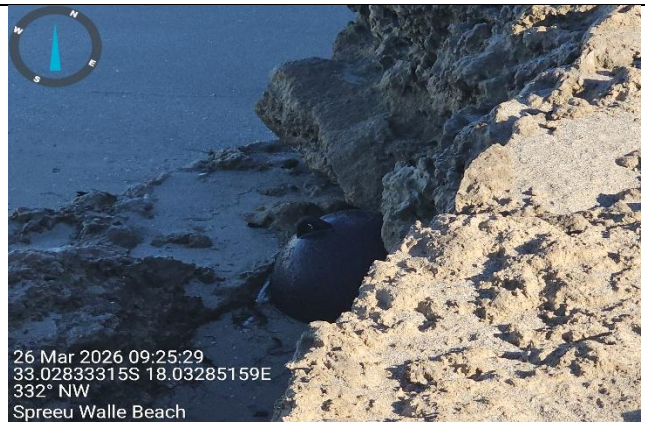
**Photograph 74:** Buoy observed at Spreeu Walle Beach during the beach inspection. Refer to co-ordinates on photo for location.

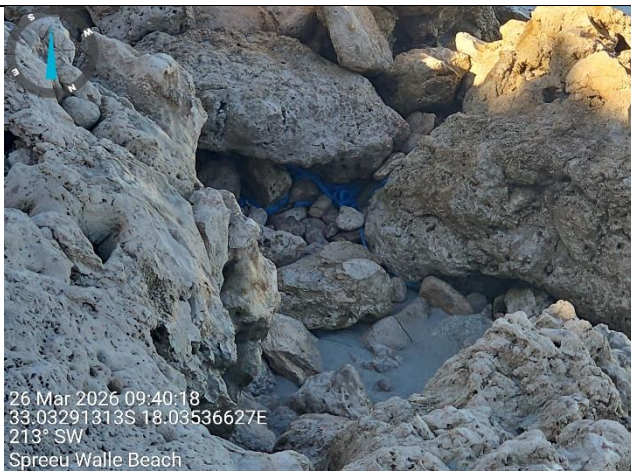
**Photograph 75:** Piece of rope observed at Spreeu Walle Beach during the beach inspection. Refer to co-ordinates on photo for location.

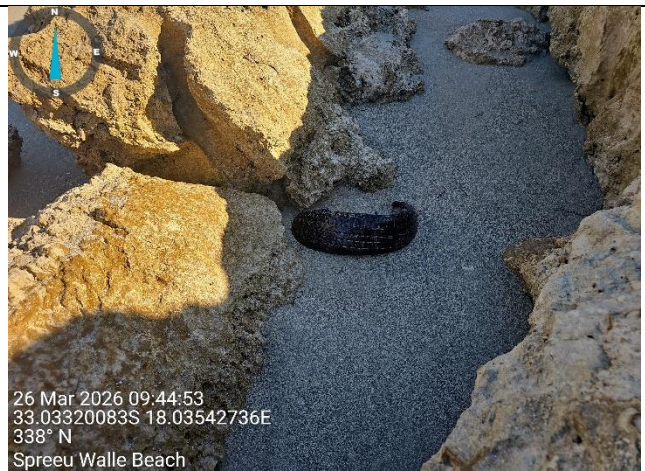
**Photograph 76:** Tyre observed at Spreeu Walle Beach during the beach inspection. Refer to co-ordinates on photo for location.

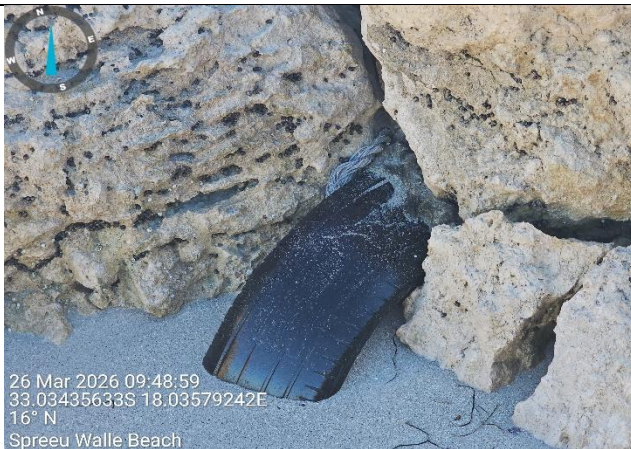
**Photograph 77:** Tyre observed at Spreeu Walle Beach during the beach inspection. Refer to co-ordinates on photo for location.

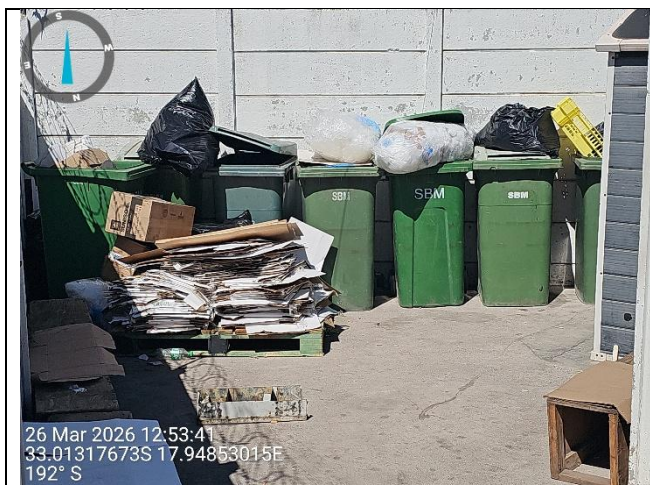
**Photograph 85:** Neat and tidy temporary waste area at the SBOC factory. All waste was separated.
