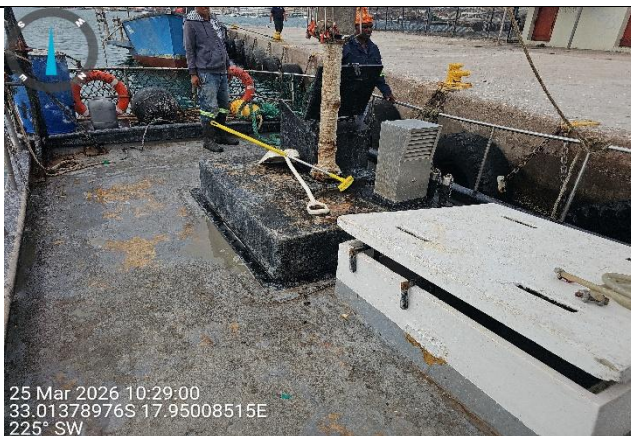
**Photograph 23:** Clean vessel was observed and safety equipment was present.

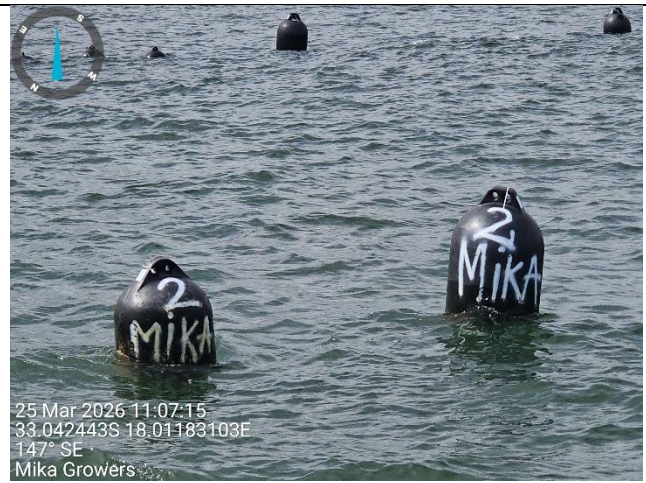
**Photograph 26:** White cable ties were used as identifying markers for Mika Growers.

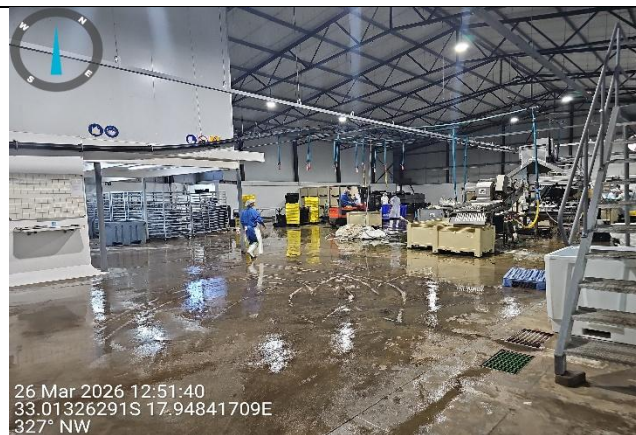
**Photograph 83:** Removal of the shells inside the processing factory of SBOC.
