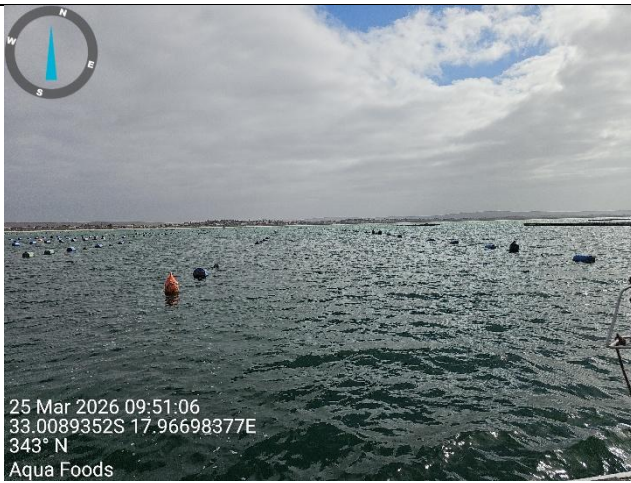
**Photograph 13:** Lines were taut and muted in colour.

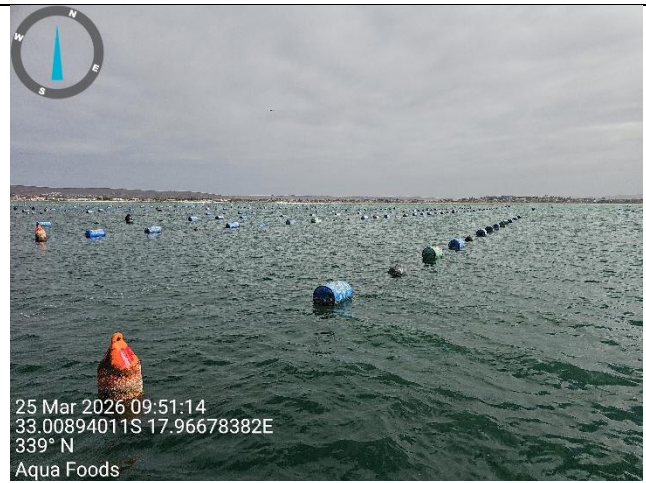
**Photograph 14:** Lines were taut and muted in colour.

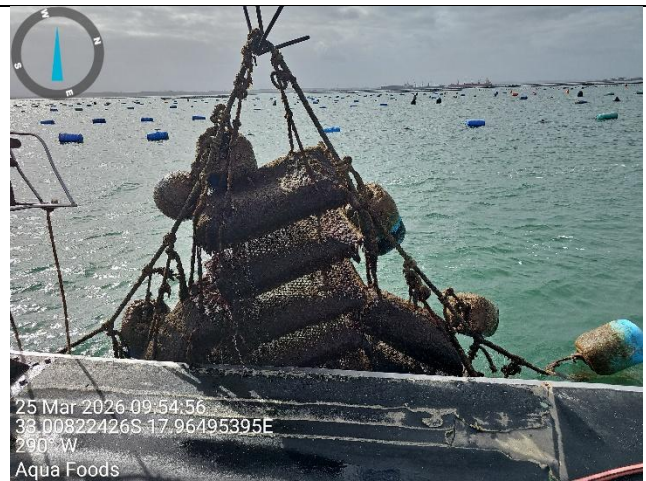
**Photograph 16:** Inspecting a random mussel line and the cages.

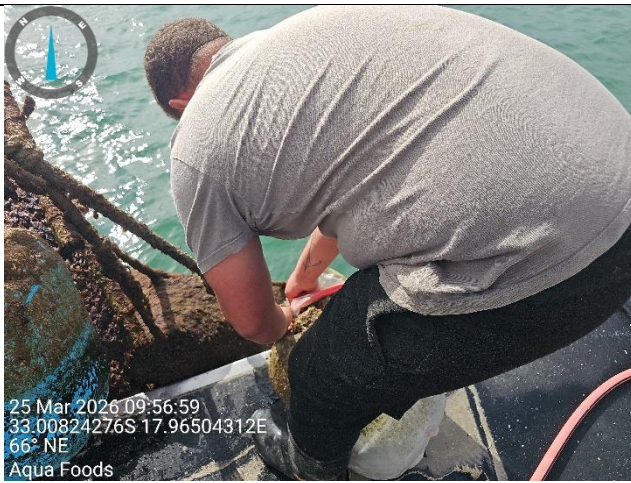
**Photograph 19:** Captain of the vessel adding a red cable tie to their buoy.

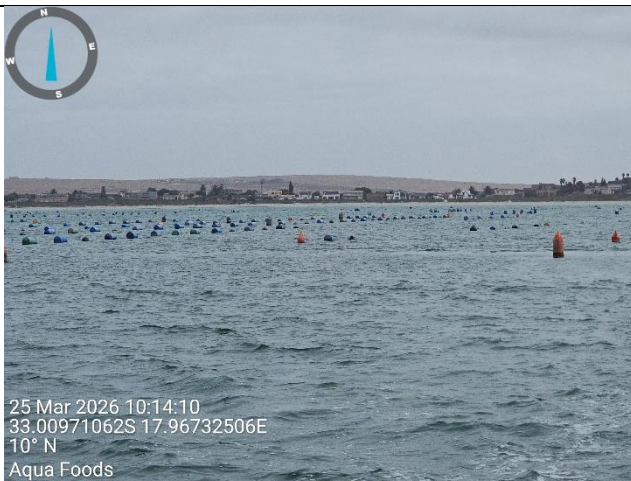
**Photograph 21:** Lines were taut and muted in colour.

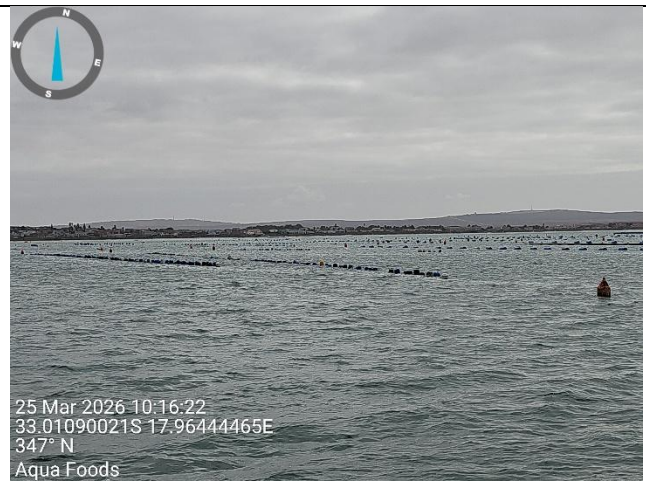
**Photograph 22:** Lines were taut and muted in colour.

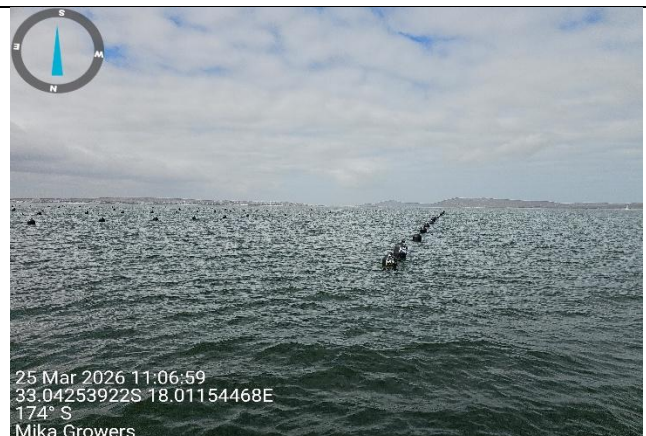
**Photograph 24:** Lines were taut and muted in colour.

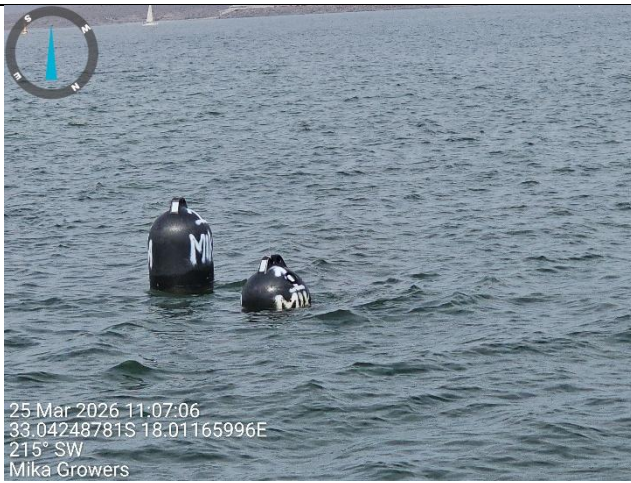
**Photograph 25:** Large floating buoys were observed on the ends of the lines.

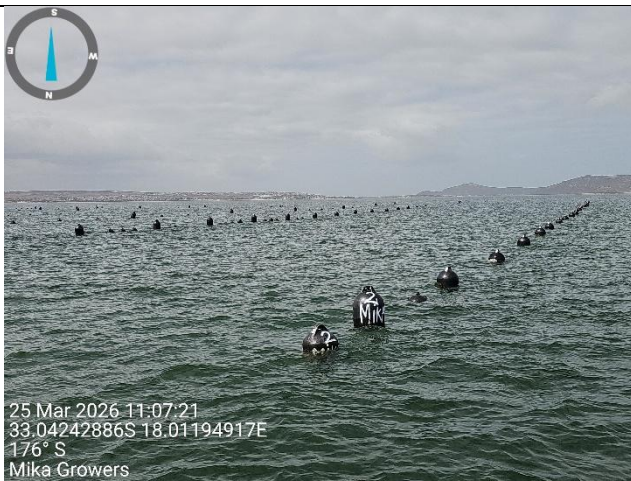
**Photograph 27:** Lines were taut and muted in colour.

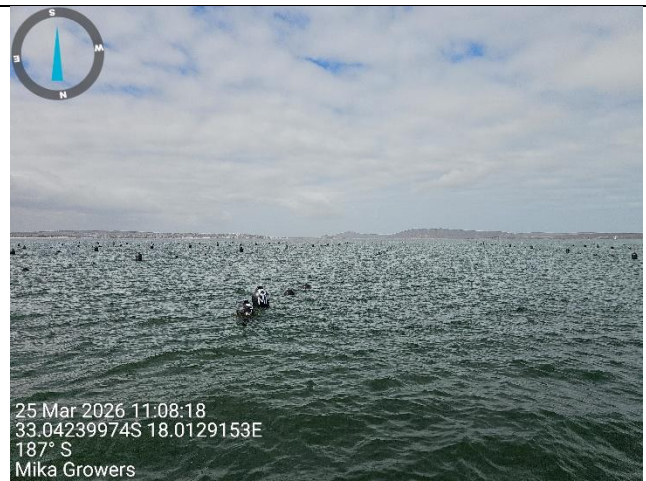
**Photograph 28:** Lines were taut and muted in colour.

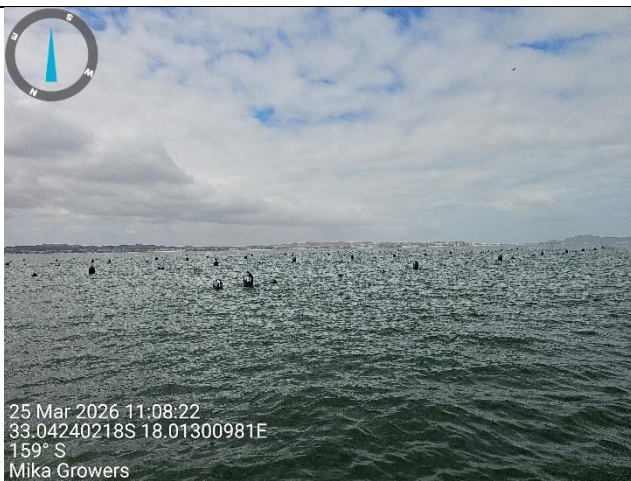
**Photograph 29:** Lines were taut and muted in colour.

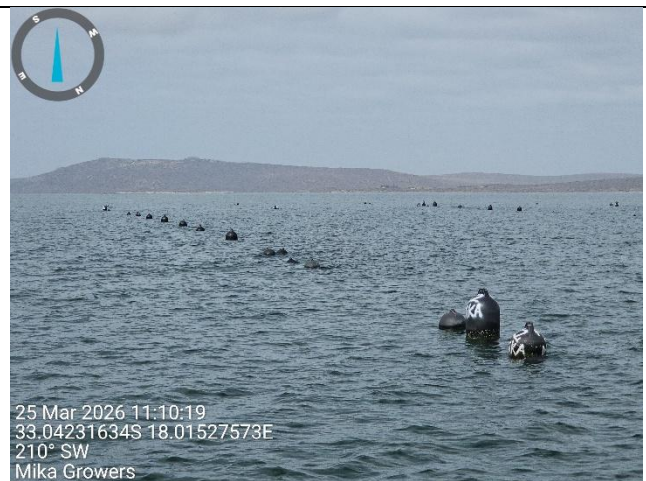
**Photograph 30:** Lines were taut and muted in colour.

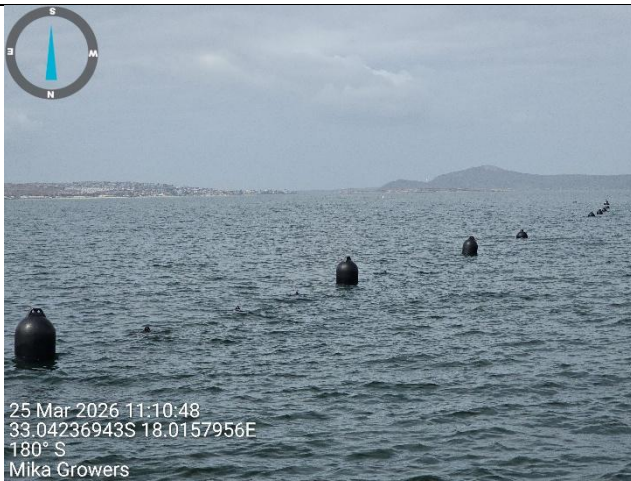
**Photograph 31:** Lines were taut and muted in colour.

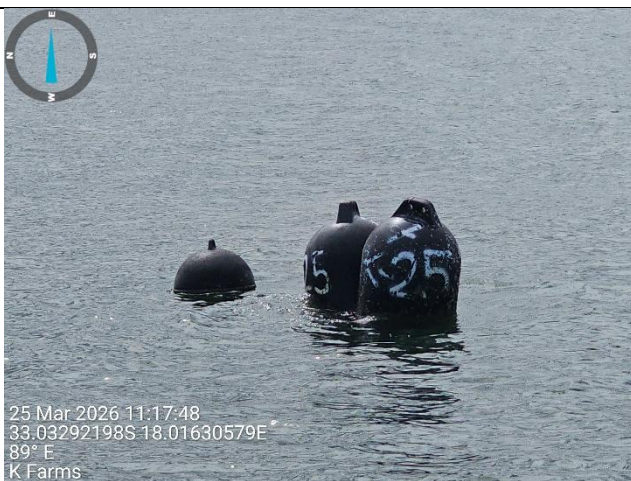
**Photograph 33:** Spray paint was used to identify the farm buoys.

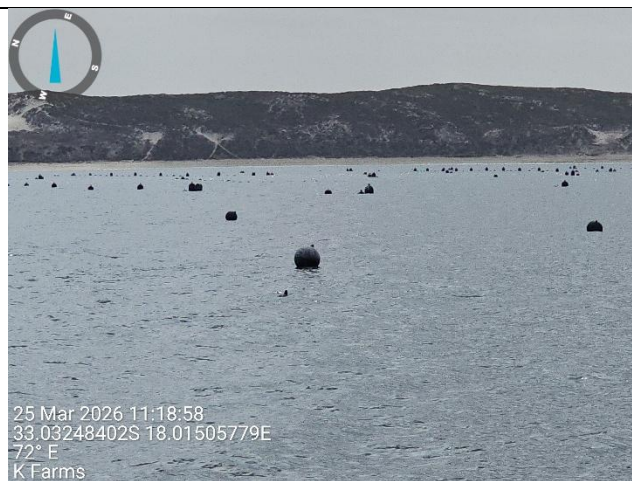
**Photograph 34:** No lines were observed in the water for K Farms. Dormant aquaculture farm.

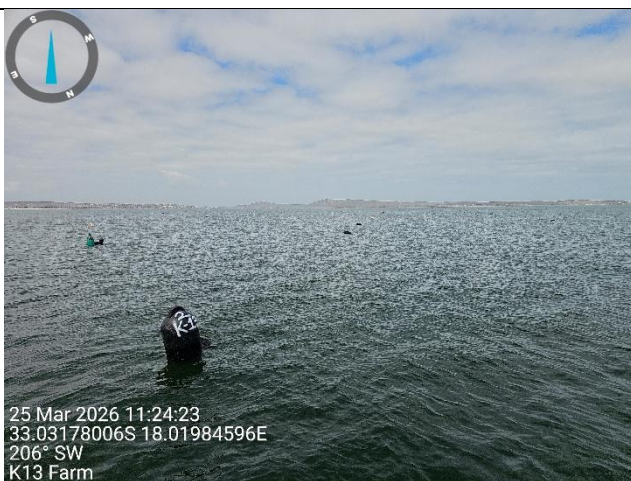
**Photograph 35:** No lines were observed in the water for K Farms. Dormant aquaculture farm.

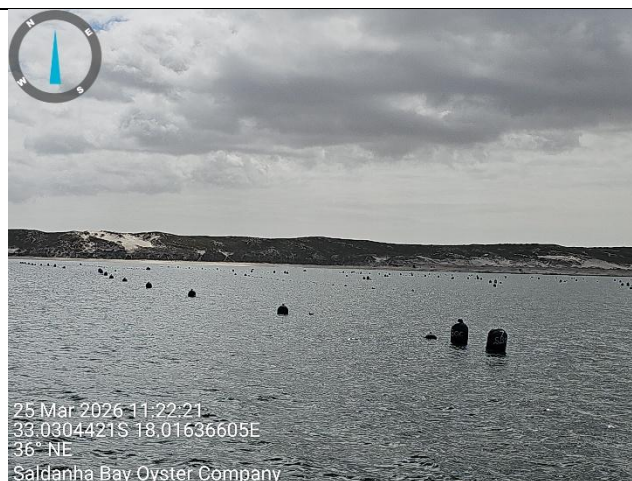
**Photograph 36:** Lines were taut and muted in colour.

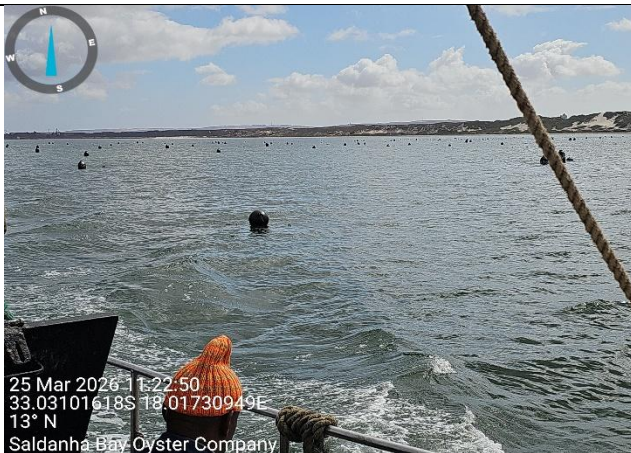
**Photograph 39:** Dormant lines were observed at SBOC.

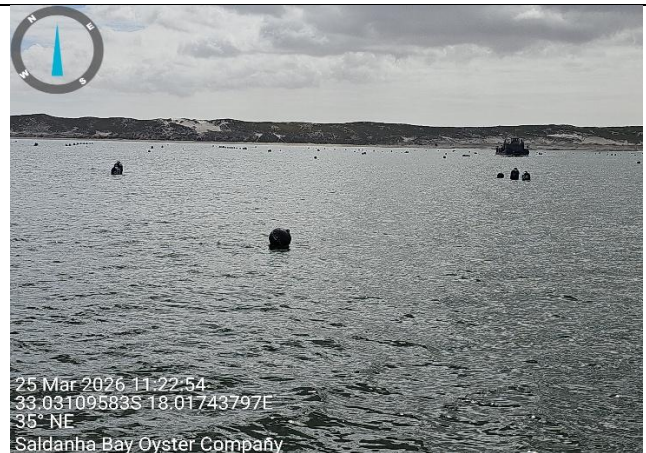
**Photograph 40:** Dormant lines were observed at SBOC.

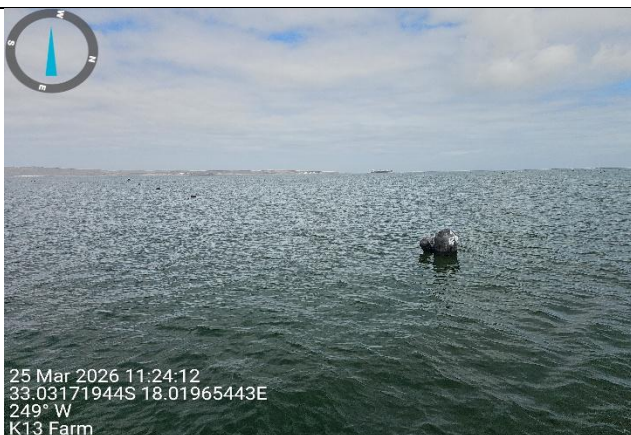
**Photograph 41:** No lines were observed in the water for K13 Farms. Dormant aquaculture farm.

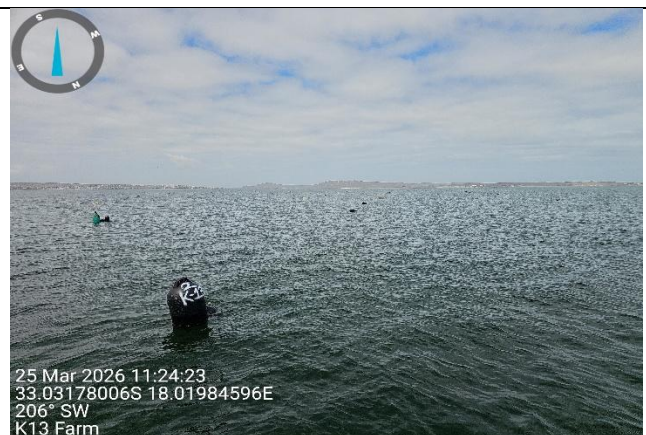
**Photograph 42:** No lines were observed in the water for K13 Farms. Dormant aquaculture farm.

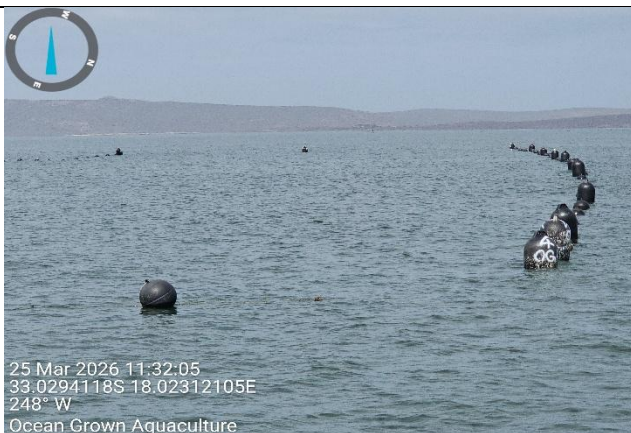
**Photograph 49:** Lines were taut and muted in colour.

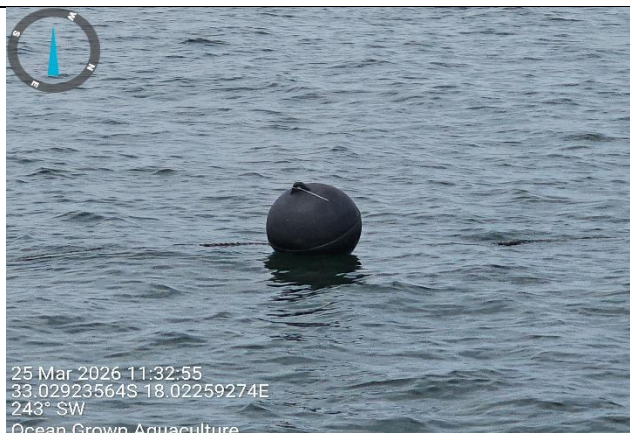
**Photograph 50:** Lines were taut and muted in colour. White cable ties were used to identify the buoys.

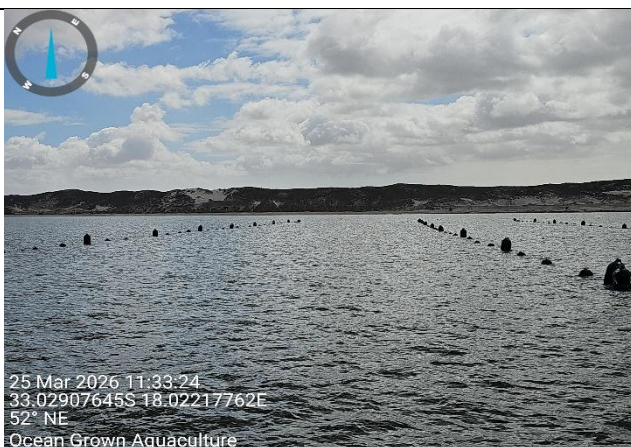
**Photograph 51:** Lines were taut and muted in colour.

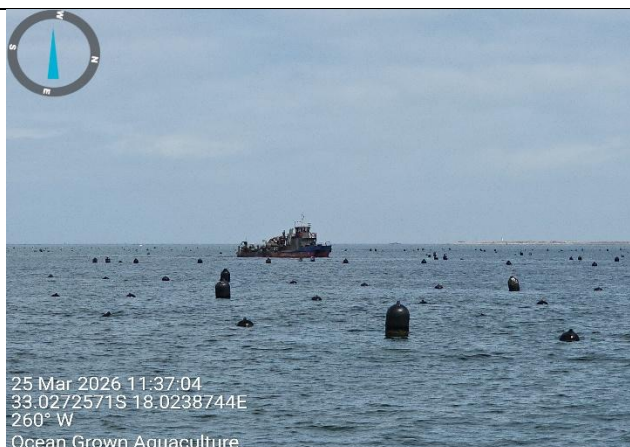
**Photograph 52:** Lines were taut and muted in colour.

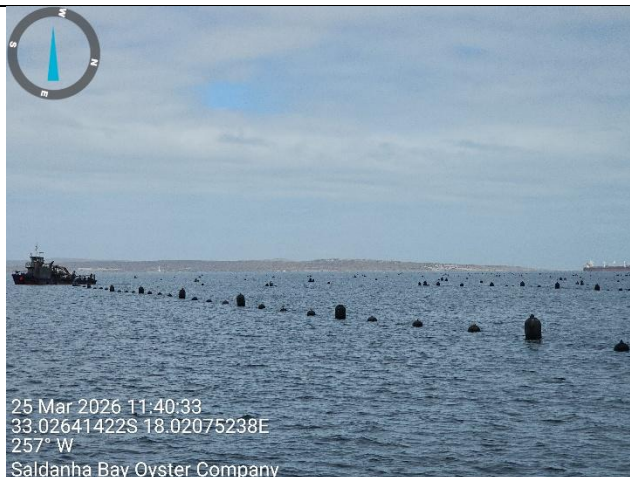
**Photograph 54:** Lines were taut and muted in colour.

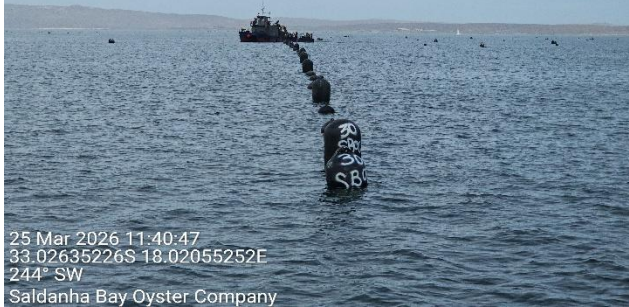
**Photograph 55:** Lines were taut and muted in colour.

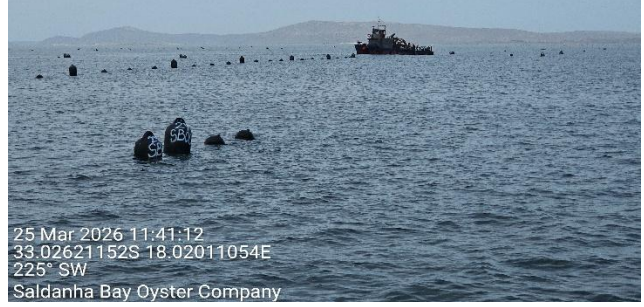
**Photograph 56:** Lines were taut and muted in colour.

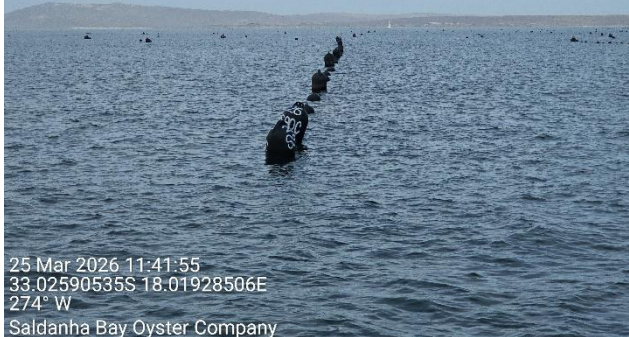
**Photograph 57:** Lines were taut and muted in colour.

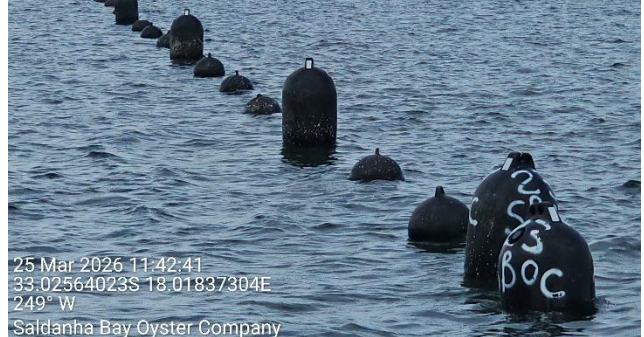
**Photograph 58:** Lines were taut and muted in colour.

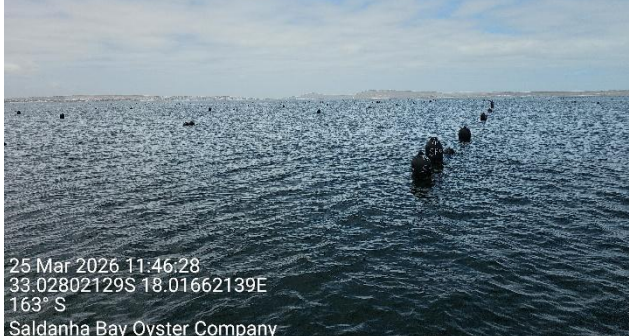
**Photograph 59:** Lines were taut and muted in colour.

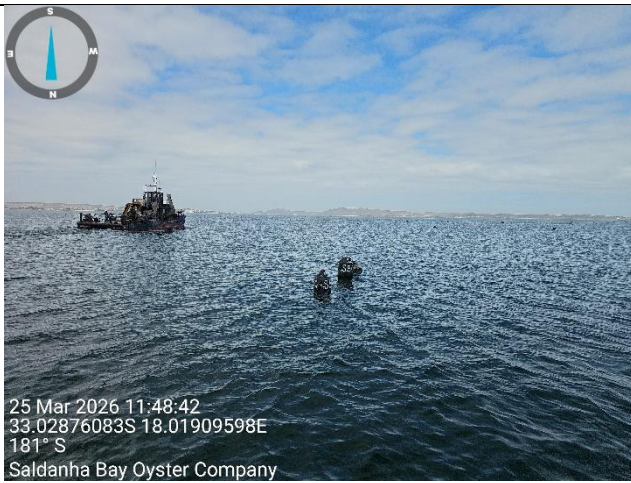
**Photograph 61:** Vessel observed harvesting during on water inspection. No oil slicks were observed.

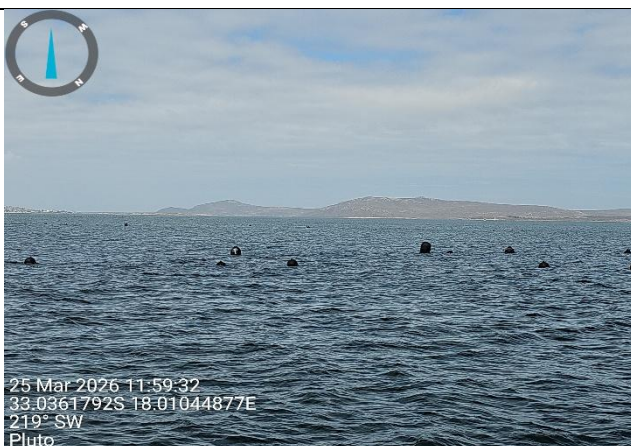
**Photograph 65:** Some of the Pluto lines seemed to be tangled.

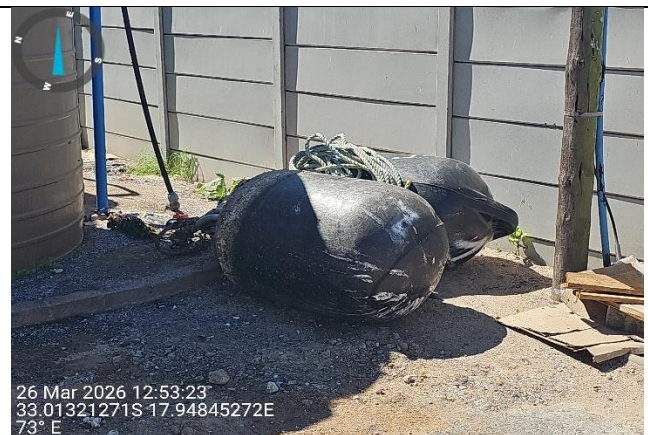
**Photograph 84:** Reusing and repairing of damaged buoys done at the SBOC factory.
